# WHITE PAPER

*Providing Sustainable Climate Control for the Archives Research Center  
at the University of Illinois*

## **Mechanical System Design and Operation Recommendations**

**Archives Research Center/Horticultural Field Laboratory**

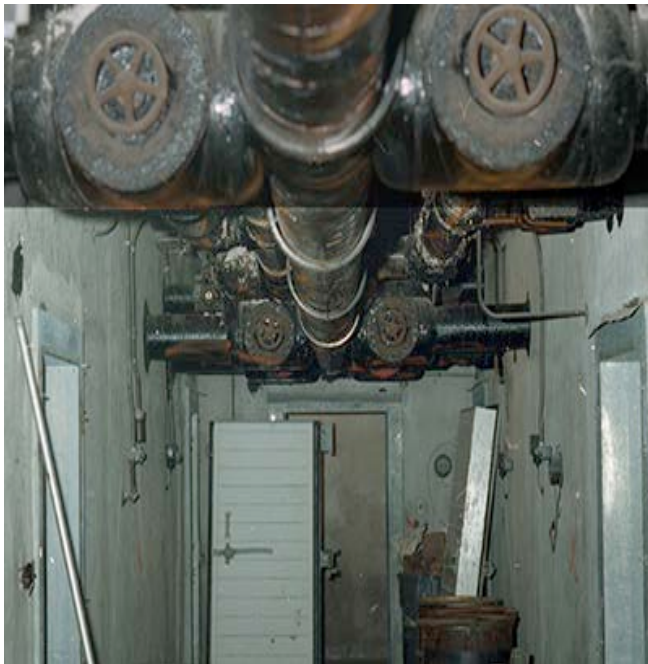
(clockwise from top left): *Image One:* The building in which the Archives Research Center resides, the Horticulture Field Lab ca. 1921. *Image Two:* Professor David Gottlieb (plant pathology), ca 1950's performing research in the Hort Field Lab. *Image Three:* Decommissioned nitrogen refrigeration system before new HVAC system was installed in the vault in the early 1990s.

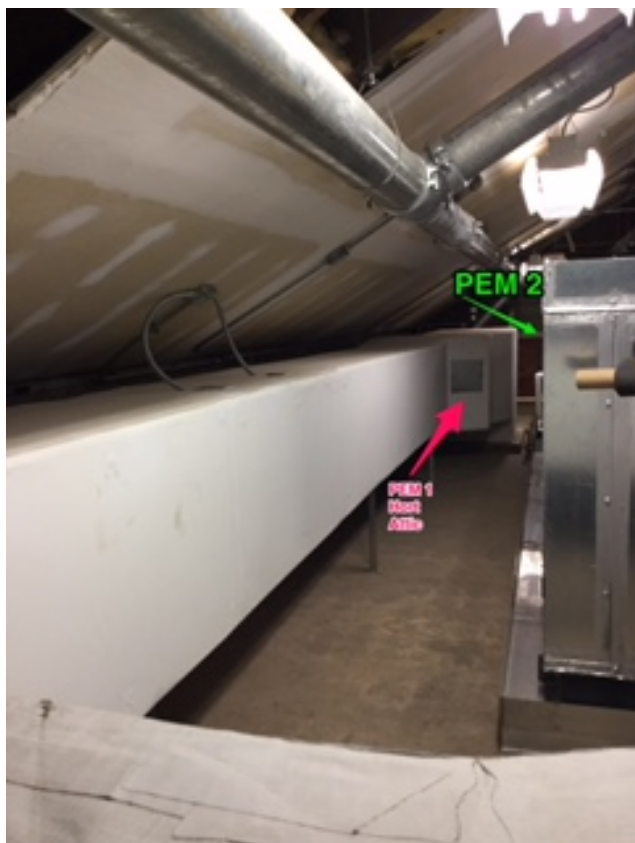
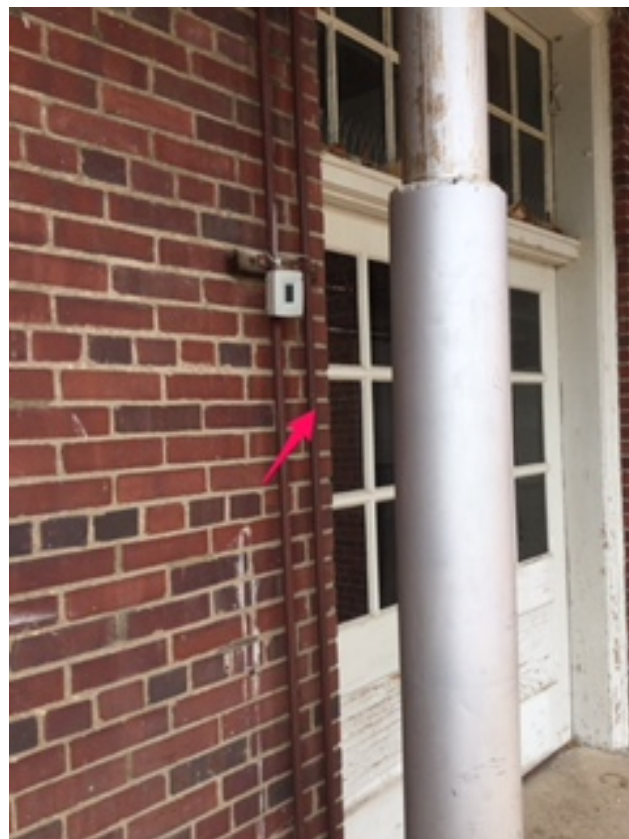
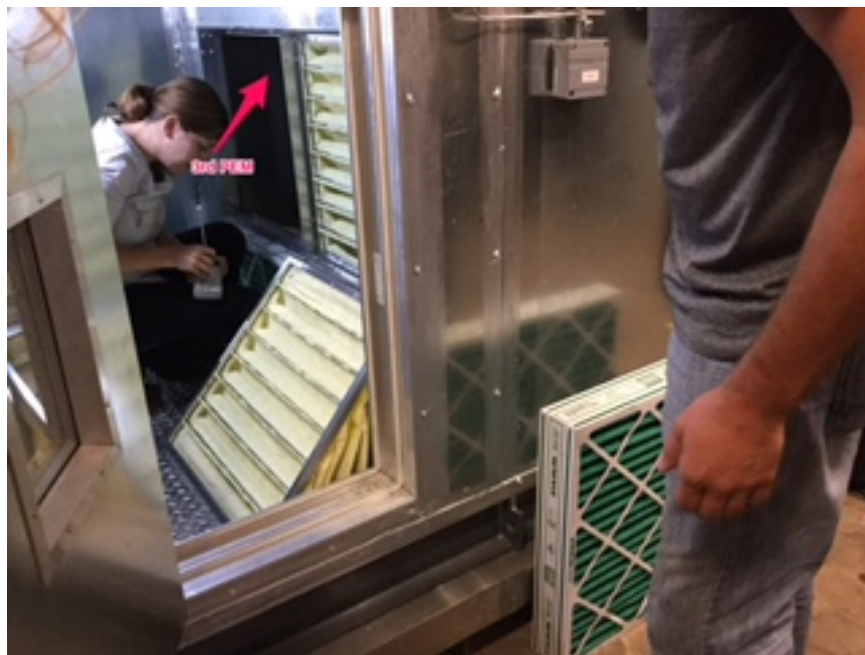
(clockwise from top left): *Image Four:* View of new AHU and ductwork in mechanical room with locations of PEM2 dataloggers. *Image Five:* Installation of exterior PEM2 datalogger to monitor outside environment immediate to the ARC building. *Image Six:* Kelly Krish installing a PEM2 datalogger into the new AHU.

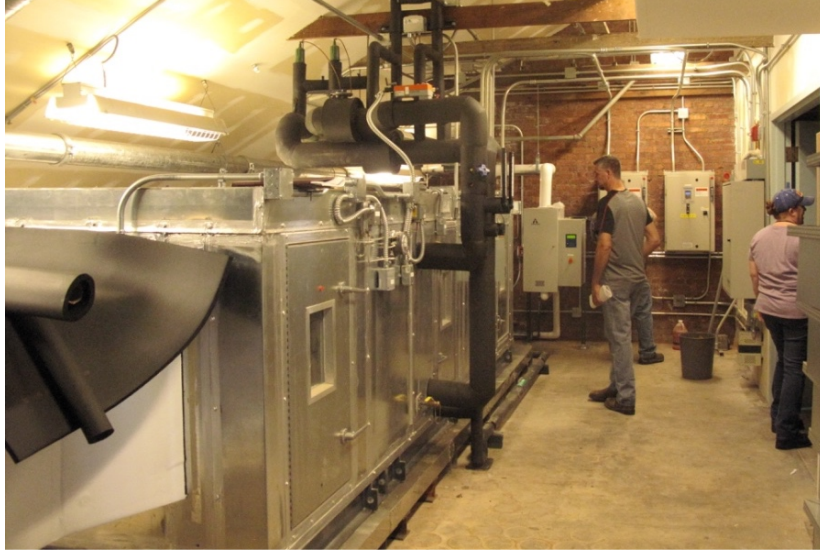
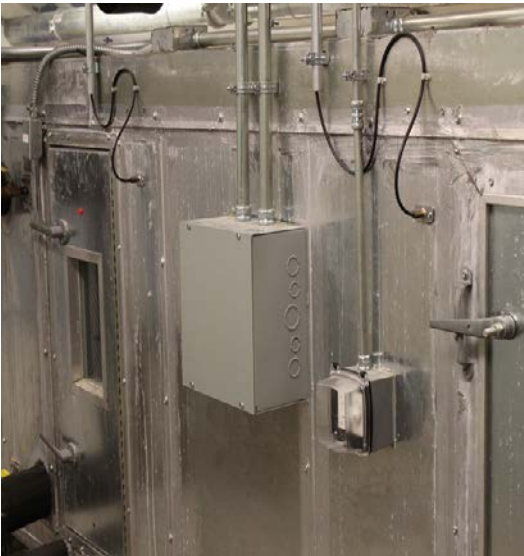
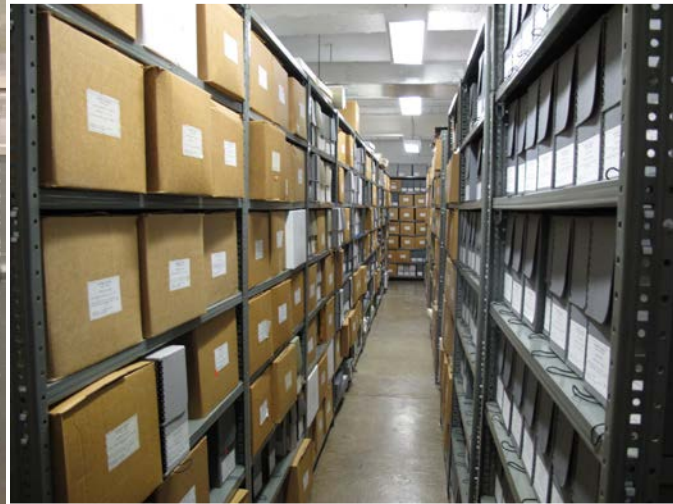
(clockwise from top left): *Image Seven:* Longer view of the new AHU in the mechanical space with Leslie Lundquist (Library Facilities) and Bill Heinz (University Facilities and Services). *Image Eight:* the archival vaults, post HVAC remodel. *Image Nine:* Evidence of condensation on the outside of the AHU, prior to construction of an enclosure in the mechanical room.

2017, issues with the system pipes freezing up were also experienced. After discussion with the planning engineers, it was quickly determined that an enclosure should have been planned around the AHU (located in an unconditioned attic space) – and plans and funds were put in place to build a conditioned space for the AHU to operate more consistently year-round. Final balancing of the system was completed in May 2017 and the system has been operating largely as expected since that time. The warranty period for the equipment (in which no deviations from the planned installation set points were possible) ran until August 2017. After the expiration of the warranty period, more flexibility with experimentation with changing seasonal set points for reduced energy consumption have been possible.

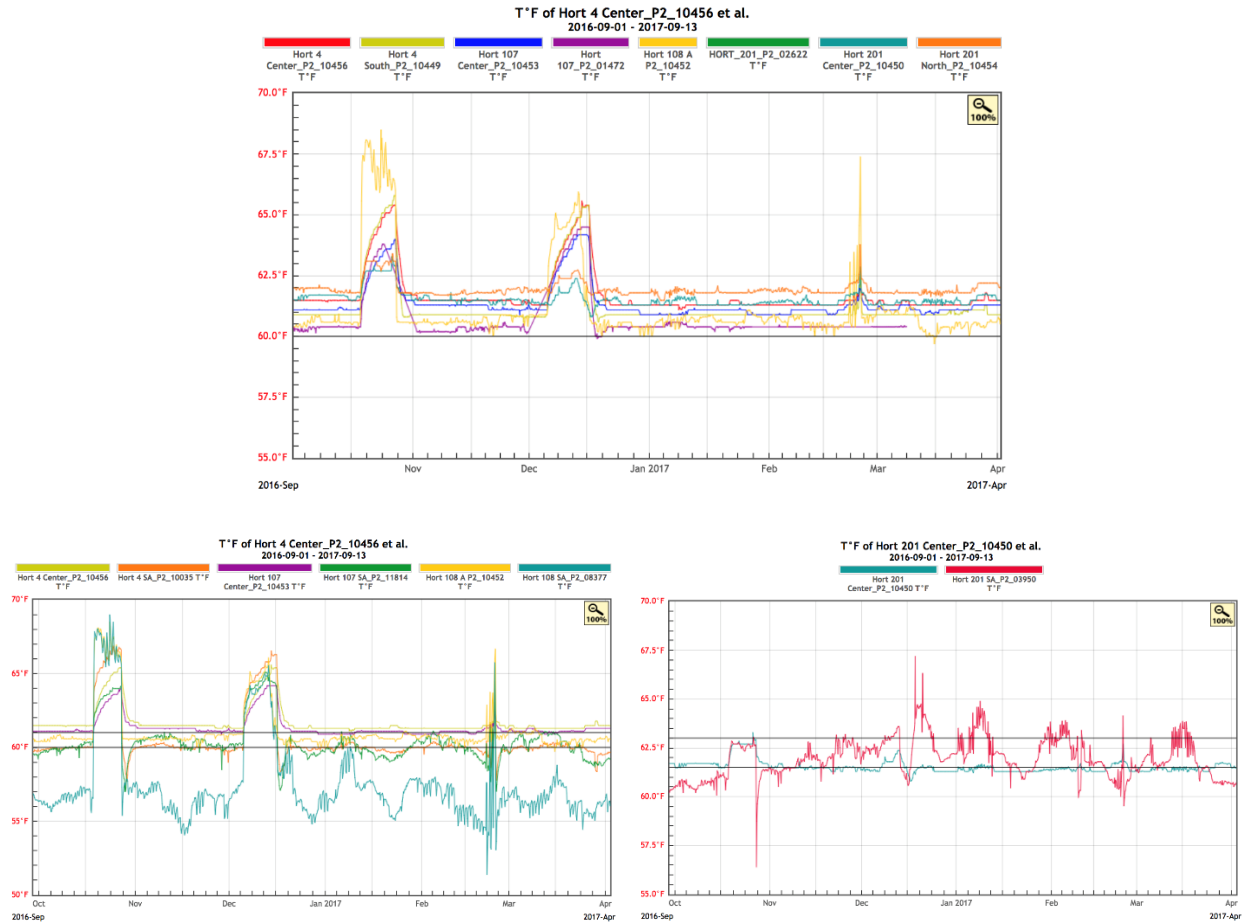
Thus far, winter set points have not been implemented, so the system continued to target 60°F throughout last year. This resulted in temperatures between 60-62°F in the spaces with periods in October and December that reached 65°F and, in the case of 108A, 68°F. These periods are believed to be the result of mechanical issues that have since been addressed. However, preservation could be greatly improved by implementing the lower winter set points to bring the average temperature down as well.

It is interesting to note that for Rooms 4, 107, and 108A, the supply air remains cooler than the spaces even in the winter, likely meaning that the spaces are receiving heat from the hallways around them that the mechanical system then has to work to counter. This has implications for the operation, as it may be that passive operation to allow the space to naturally drift down to lower temperatures in the winter is not as much of an option as originally thought.
